A supplement to World Pipelines – Volume 23 Number 8 – August 2023

BITUMEN VS BUTYL: WHICH IS SUPERIOR?

Thomas Kaiser, Managing Director, DEKOTEC GmbH, considers whether PVC/bitumen or PE/butyl rubber is better suited for use in corrosion protection tapes.

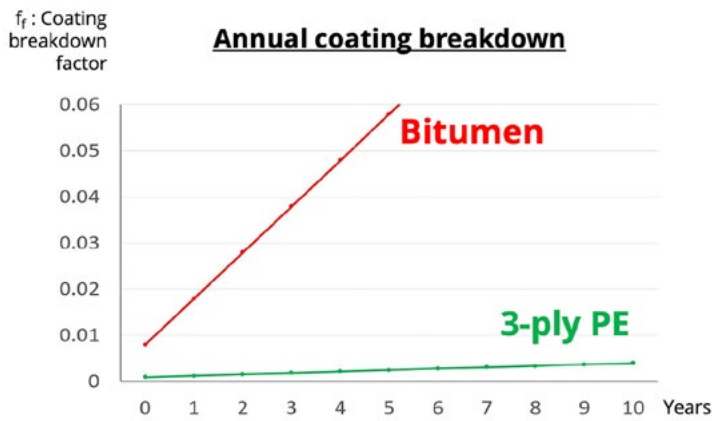
Figure 3. Annual coating breakdown.

The problem of porosity in pipeline coatings is measured by their degradation and recorded by a coating breakdown factor (f_f). Comparing coatings made from bitumen with those made from three-layer PE (3LPE) shows that the degradation factor of bitumen is much higher than that of 3LPE even right from the start, i.e. immediately after the coating is applied. The degradation of the bitumen coating reaches 25 times that of a 3LPE coating after just five years, as shown in Figure 3.
